**Talon Pointe Metro District  
Thornton, CO**

Report #: 49612-0  
Beginning: January 1, 2024  
Expires: December 31, 2024

**RESERVE STUDY  
"Full"**

September 29, 2023

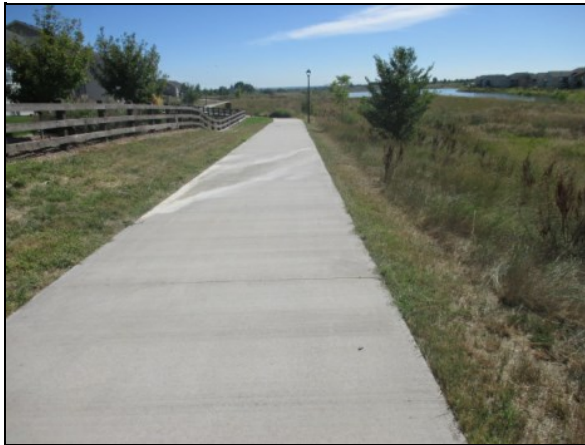
**Comp #: 21090 Concrete Walkways - Repair - 5%**

Comments: Concrete sidewalks determined to be in fair condition typically exhibit minor changes in slope and a moderate percentage of cracking and surface wear. Trip hazards may be increasing in frequency and severity and should be closely monitored to prevent further risks. The Rocky Mountain Region is home to expansive soils. One of the causes of concrete damage in this type of climate is soil moisture. Expansive soils tend to swell in size when wet and contract as they dry out. As the soil expands and contracts it can create enough force to cause major damage to sidewalks. Repair any trip and fall hazards immediately to ensure safety. As routine maintenance inspect regularly pressure wash for appearance and repair promptly as needed to prevent water penetrating into the base and causing further damage. In our experience larger repair/replacement expenses emerge as the community ages. Although difficult to predict timing cost and scope we suggest a rotating funding allowance to supplement the operating/maintenance budget for periodic larger repairs. Adjust as conditions actual expense patterns dictate within future reserve study updates.

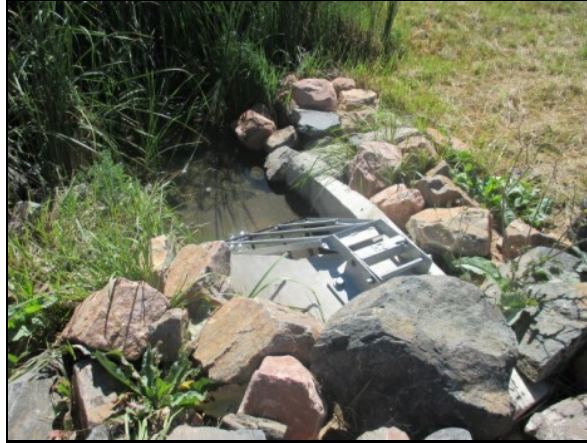
Comments: No access to inspect in-ground drainage infrastructure. Annual preventive maintenance work is typically performed as part of an client's general maintenance/operating fund. Under normal circumstances site drainage components are constructed of very durable materials which should have a very long useful life (often assumed to be 50 years or more). Repairs may occasionally be required but timing and scope of work is too unpredictable for Reserve funding in accordance with National Reserve Study Standards. If there are specific known concerns with drainage system we recommend further investigation using cameras or other means to document and identify conditions. Some clients consult with civil and/or geotechnical engineers in order to develop scopes of work for repair/replacement. If more comprehensive analysis becomes available findings should be incorporated into Reserve Study updates as appropriate.

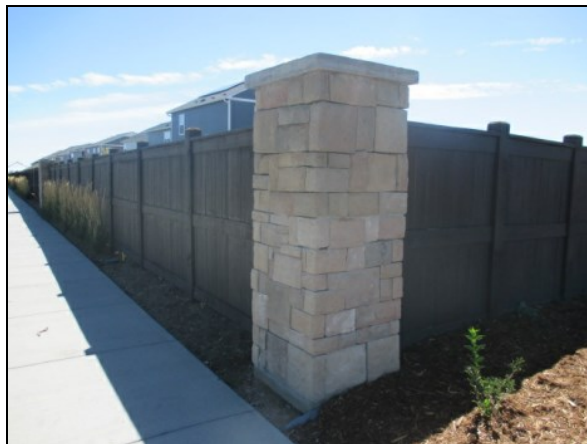
**Comp #: 21320 Fence: Double Sided - Paint/Stain**

Comments: Wood fencing determined to be in fair condition typically exhibits a finish coat which is mostly uniform but exhibits minor to moderate surface wear or fading possibly exposing wood substrate in some areas. Regular uniform professional paint or sealer applications are recommended for appearance protection of wood and maximum design life. Repair as needed and clean prior to application. Plan for regular applications as shown below. Timing of repair/paint cycles may need to be coordinated with eventual fence replacement.

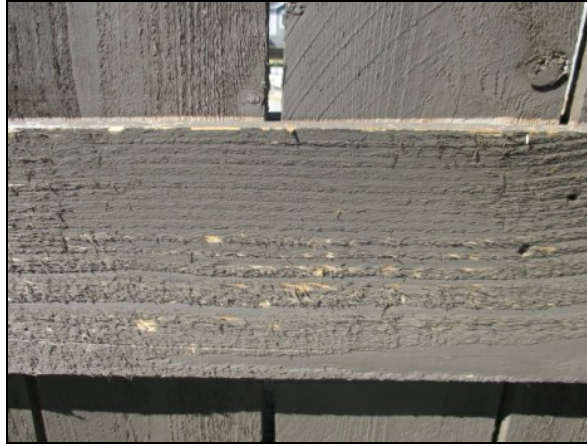
**Comp #: 21320 Fence: Single Sided - Paint/Stain**

Comments: Wood fencing determined to be in fair condition typically exhibits a finish coat which is mostly uniform but exhibits minor to moderate surface wear or fading possibly exposing wood substrate in some areas. Regular uniform professional paint or sealer applications are recommended for appearance protection of wood and maximum design life. Repair as needed and clean prior to application. Plan for regular applications as shown below. Timing of repair/paint cycles may need to be coordinated with eventual fence replacement.

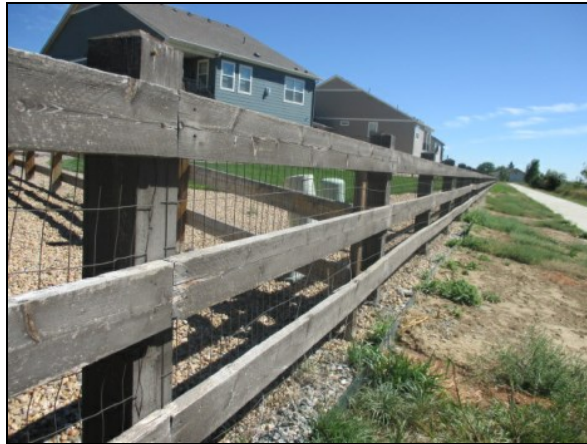
**Comp #: 21320 Fence: Three Rail - Paint/Stain**

Comments: Wood fencing determined to be in fair condition typically exhibits a finish coat which is mostly uniform but exhibits minor to moderate surface wear or fading, possibly exposing wood substrate in some areas. Regular uniform, professional paint or sealer applications are recommended for appearance, protection of wood and maximum design life. Repair as needed and clean prior to application. Plan for regular applications as shown below. Timing of repair/paint cycles may need to be coordinated with eventual fence replacement.

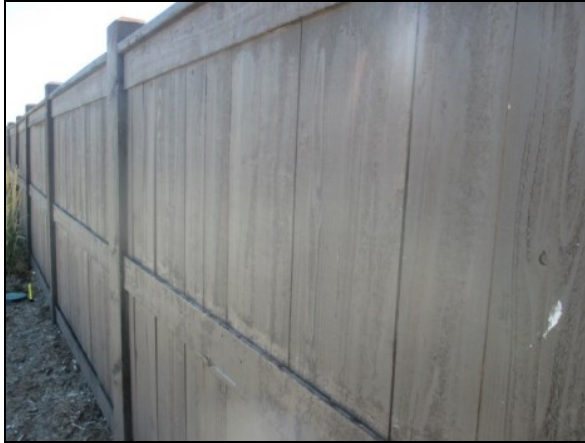
**Comp #: 21330 Fence: Double Sided - Replace**

Comments: Wood fencing determined to be in fair condition typically exhibits some minor to moderate amounts of surface wear and other signs of age which may include a small percentage of warped split and/or rotted sections. In general appearance is consistent but declining. As routine maintenance inspect regularly for any damage repair as needed and avoid contact with ground and surrounding vegetation wherever possible. Regular cycles of uniform professional sealing/painting will help to maintain appearance and maximize life. In our experience wood fencing will typically eventually break down due to a combination of sun and weather exposure which is sometimes exacerbated by other factors such as irrigation overspray abuse and lack of preventive maintenance. Recommendation and costs shown here are based on replacement with similar style and material. However the client might want to consider replacing with more sturdy lower-maintenance products like composite vinyl etc. Although installation costs are higher total life cycle cost is lower due to less maintenance and longer design life expectancy.
